# Work Health and Safety Report

## MOUNT VIEW APARTMENTS - CTS 32752

29-37 Rise Street  
MOUNT GRAVATT QLD 4122

28 October 2015

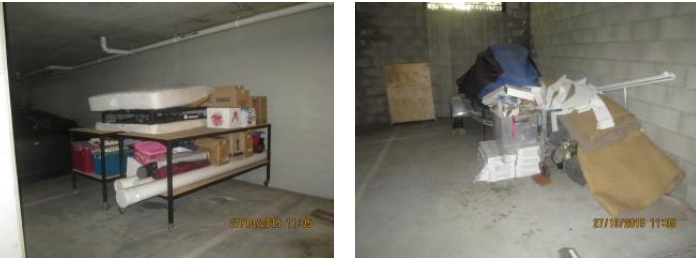
4) Was the basement car park, free of excessive amounts of combustibile material (household items that could burn)?	<b>NO</b>
<p><b>Observation:</b> There were stored household items that could be used as flammable material to start a fire.</p> <p><b>Recommendation:</b> We recommend a general tidy up and to minimise the amount of stored flammable and combustibile material in the basement.</p>	
<b>Risk Indicator:</b> LOW	
<p><b>Photos:</b></p>

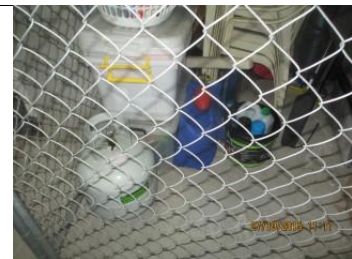
**Observation:** LP Gas cylinder stored in storage lockup in the basement. LP Gas is heavier than air and will pool if not ventilated properly.

**Risk Indicator:** MEDIUM

**Recommendation:** We recommend removing LP gas cylinders from basement, or installing cylinders in a purpose built Flammable gas cupboard.
